# APPLICATION NOTE

## FLIR GF346 Gas Detection Camera Used at Tata Steel Ltd. to Detect Carbon Monoxide Gas

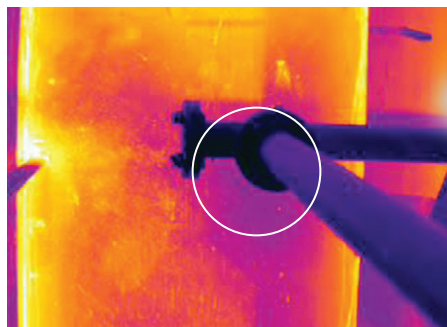
LD#2 caster- leakage through tundish heating line blanking joint.

One of the first uses for the company's GF346 was to find an elusive leak near the Caster #2 casting floor. Amitabha Guha, Senior Manager (inspections) at Tata Steel, said his crew was unable to detect the CO gas leak source in the casting floor area. The leak began in the late evening hours, so a lack of sunlight and the frequent change in natural air flow direction made it difficult to trace out the source of leakage.

With the help of the GF346 thermal imaging camera, inspectors scanned all possible sources of the leakage point near gas pipe lines. They found no gas leak in the region around the steel-making unit (LD2&SC), so they decided to scan the gas lines outside the LD2 premises. The crew finally detected the source of the leak in a Fuel Management Department main CO line, which is 60 meters away from the casting floor. Gas was escaping from a flange joint in a line that supplies gas to the hot strip mill (HSM) reheating furnace from the gas mixing station. Inspectors closed off and secured the area, then communicated their findings HSM & FMD for immediate corrective action. Repairs began immediately, preventing an unsafe incident and closing off the source of the leak.

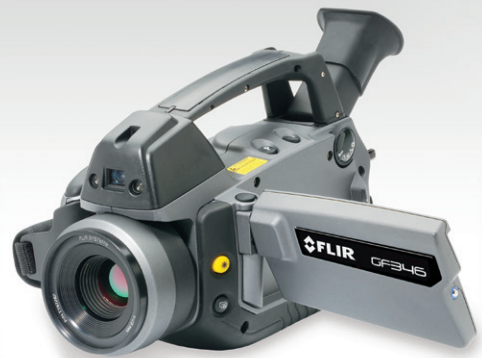
The FLIR GF346 optical gas imaging camera visualizes CO and 17 additional gases.

The FLIR GF346 uses a specially filtered thermal detector to visualize carbon monoxide (CO) and other harmful gases. The camera can be used to quickly scan for gas across wide areas and from a safe distance, without the need to interrupt a plant's production process. As CO emissions can be a significant threat to steel manufacturing operations, emissions need to be closely watched. Even the slightest leak in a vent stack or pipe can have a devastating effect. The FLIR GF346 can scan potential leak points rapidly, and allow the user to pinpoint their source in real time.

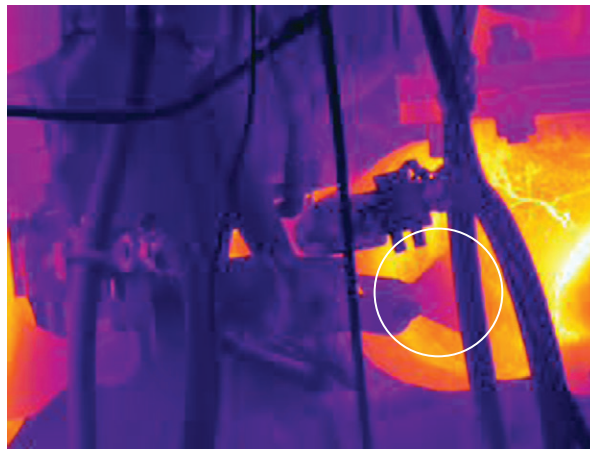
*HBF tuyer #7*

Tata Steel used the FLIR GF346 to inspect all of its blast furnaces, which produce liquid iron for steel making. Blast furnaces have tuyers for supplying hot blast to the furnace burden that are fitted to the furnace shell. Frequent leakage of CO gas from these tuyers creates an unsafe and unhealthy atmosphere at the tuyer platform and above. Inspectors used the GF346 to scan all 34 tuyers and identified the leaky tuyers from a safe distance. As before, Tata Steel took immediate corrective action and updated the tuyers with a new welded design. After changing the tuyers, they scanned with the GF346 again and found that the leaks were eliminated. As a result, operating personnel are now working in a gas-free environment. Inspectors ensuring they had proper Delta T – or temperature difference between the target and the background scene – to achieve the optimal image contrast needed to detect the lowest level of gas emissions using the GF346's high sensitivity mode.

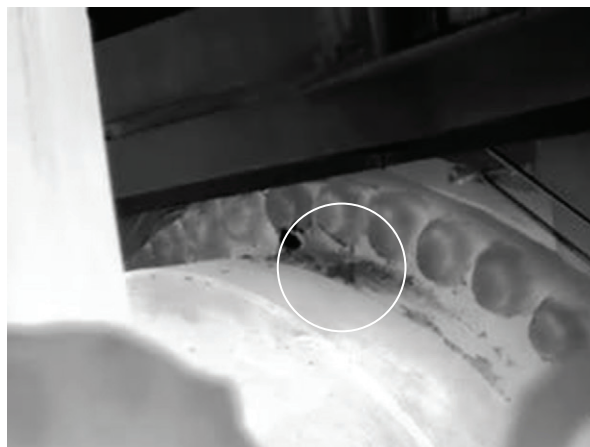
*HBF leakage through GV #1*

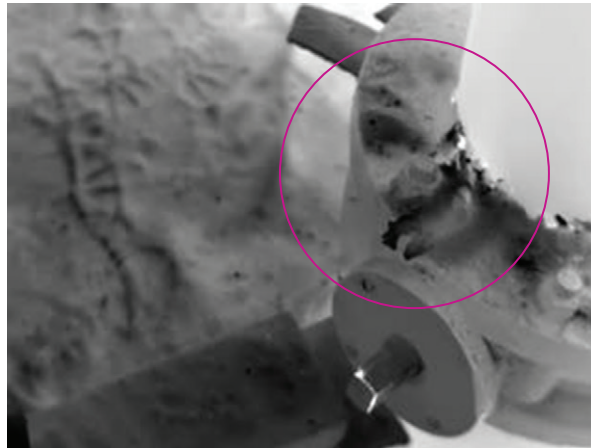
HSM pipe leakage at FCE #1

The Tata Steel hot strip mill (HSM) produces hot-rolled sheets for automobile and LPG grades. The mill is fed by three reheating furnaces which use carbon monoxide-rich blast furnace gas and coke oven gas as fuel. Leakage of unburnt CO was identified through the camera, and inspectors quickly and safely found the source of the leak at three locations in the pipe joints. HSM took immediate corrective action to eliminate the presence of CO near the furnace.
